TO: Dill Customers

May 6, 2008

There have been recent reports of a concern with certain rubber snap-in valve stems manufactured under the Dill-ACP brand name and distributed by Dill Air Controls Products, LLC. As a result of recent reports and our investigation, we are advising of this concern affecting TR 413, TR 413 chrome, TR 414, and TR 418 Dill ACP valve stems.

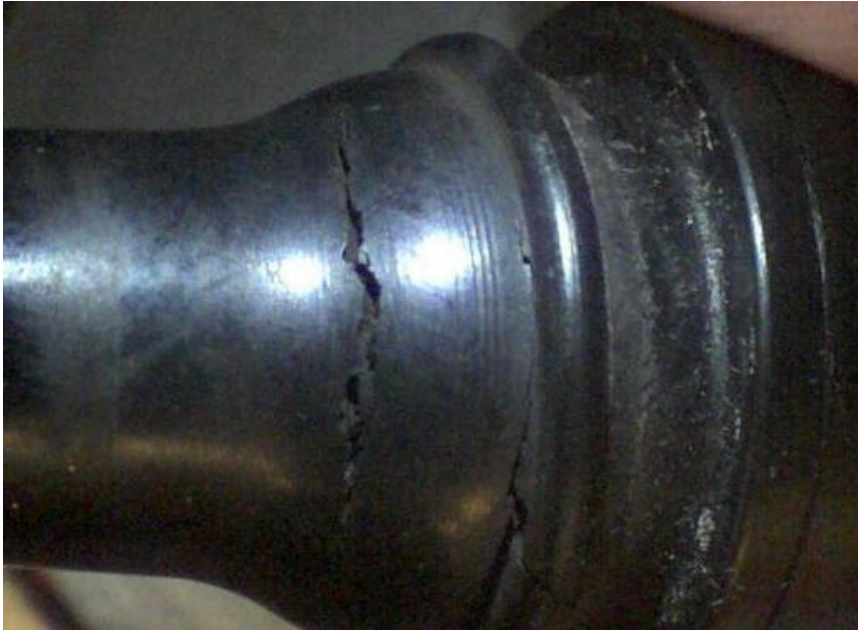
We have received a number of parts showing surface cracks on the outside of the rubber near the rim hole. Our initial investigation based on this anecdotal evidence has centered on ozone exposure. When the rubber is exposed to high levels of ozone as it is being stressed, surface cracks can appear. High speeds and an unsupportive rim profile allow the rubber valve to flex at a greater angle and may cause these cracks to propagate, leading to a slow leak of air.

2. Out of an abundance of caution, we are recommending that when customers return to your stores for regular service, you inspect the valves stems on vehicles who received valve stems during the period from September 2006 – June 2007. This can be done by flexing the valve in a clockwise direction around the rim and looking for cracks above the indicator ring of the valve, for example:

Those valve stems that contain visible surface cracks should be removed and replaced with a new valve stem. This affects the following stems:
